No. SDFS2311007061FR

### **FACTORY DIRECT LIGHTING (2020) LTD**

Sample Description: LED DOWNLIGHT

The fire resistance performance of loadbearing timber floor assembly protected by a fiber reinforced calcium silicate board ceiling, incorporating six LED downlights, in accordance with UL 263:2022 /ASTM E119:2022 /CAN/ULC-S101-07.

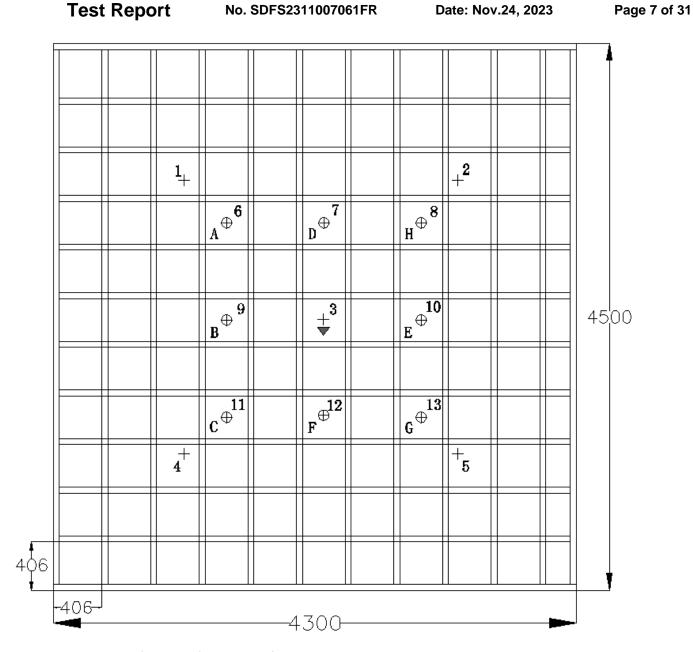
Figure 1 - General Plan of Test Sample from Unexposed Face and Thermocouple Positions (Unit: mm)

- + Unposed face thermocouple position
- Downlight position
- Deflection measurement points

The timber floor had overall nominal dimensions of 4300 mm long by 4500 mm wide and comprised softwood timber joists spaced 406 mm.

The tested sample was supported on the horizontal furnace with an opening of the 4000 mm by 4200 mm. The all around of the furnace wall was covered by ceramic fiber cotton. The tested sample was asymmetrical. At the request of client, the sample was mounted such that underside (Fiber reinforced calcium silicate board ceiling) towards to the heating conditions of the test.

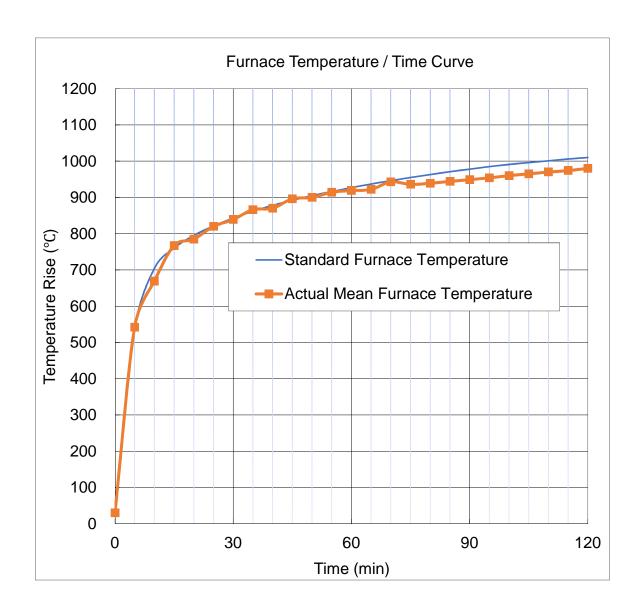
Figure 3 - Standard and actual Mean Furnace Temperature/Time Curve

The specified side (under side) of floor sample was exposed to elevated temperatures as dictated in standard time-temperature curve for a period of 120 minutes.

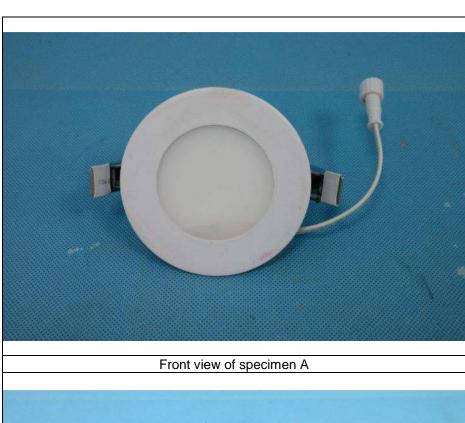
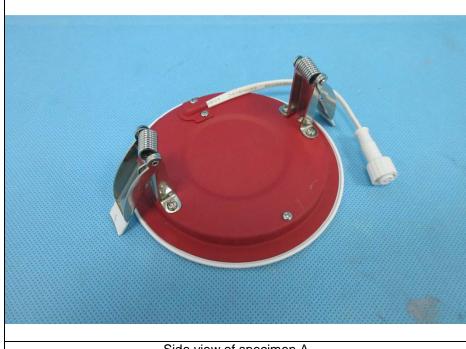
Side view of specimen A

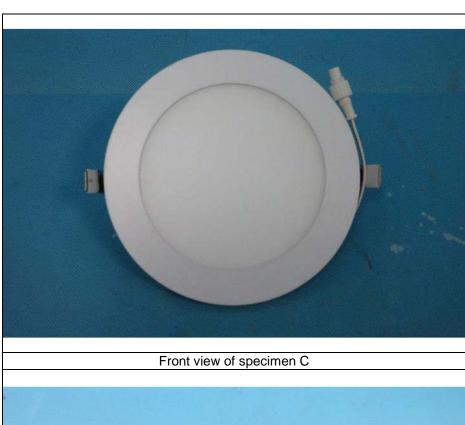
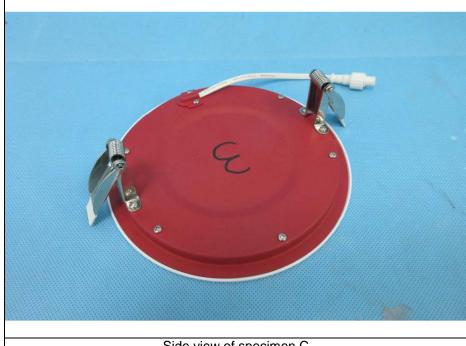
Side view of specimen C

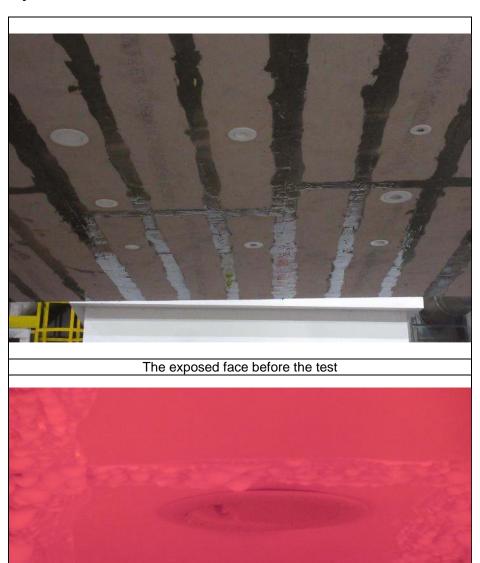
The exposed face after test duration of 31 minutes

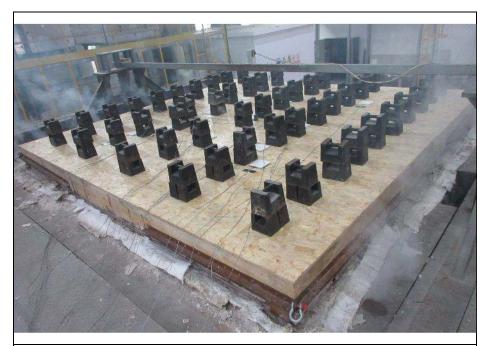
The unexposed face after test duration of 40 minutes

Time(min:s)	Observation (All observations are from the unexposed face)
00:00	Furnace fired and test was started.
05:12	A slight amount of smoke released from the ends of the floor assembly.
10:04	Some smoke released from the seam on the unexposed face of the floor assembly.
70:00	No obvious change on the unexposed face of the floor assembly.
90:00	No flames were found emitting from all downlight positions.
100:02	No obvious change on the unexposed face of the floor assembly.
120:00	The floor assembly was maintaining its integrity and insulation.
121:00	Test was terminated as per client requirement.

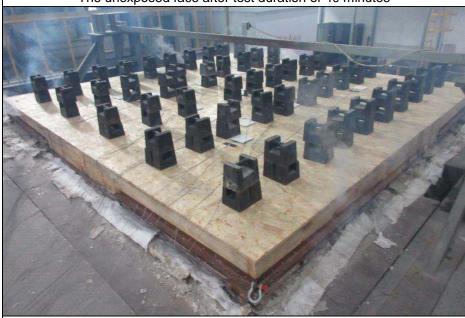
The unexposed face after test duration of 92 minutes
